TEST REPORT

INVERTER/CHARGER

Alpha V III 3kw/5kw-48v

Report No.: WT166003315

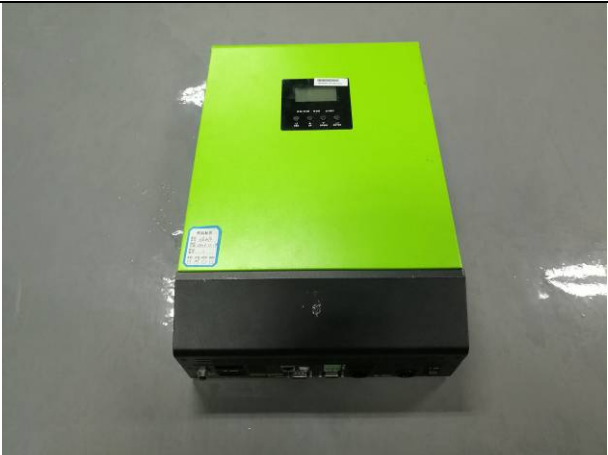
Before the test, the specimen exhibited no external physical damage.

No.	Depiction	Photo
1	Inspection before the test

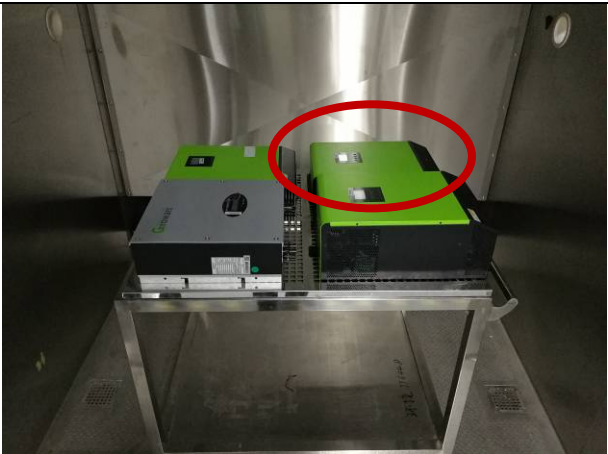
2	Low temperature test, High temperature test, Damp heat cyclic test, Damp heat test and Change of temperature test specimen setting (Note: The red circle indicated the specimen)

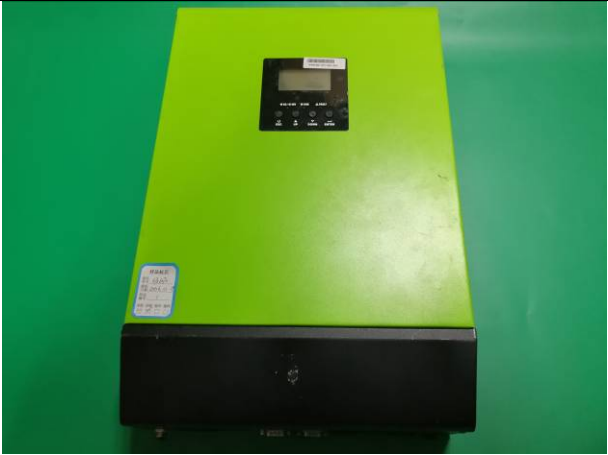
After the test, the specimen exhibited no external physical damage.

3	Inspection after test (Low temperature test, High temperature test, Damp heat cyclic test, Damp heat test and Change of temperature test)

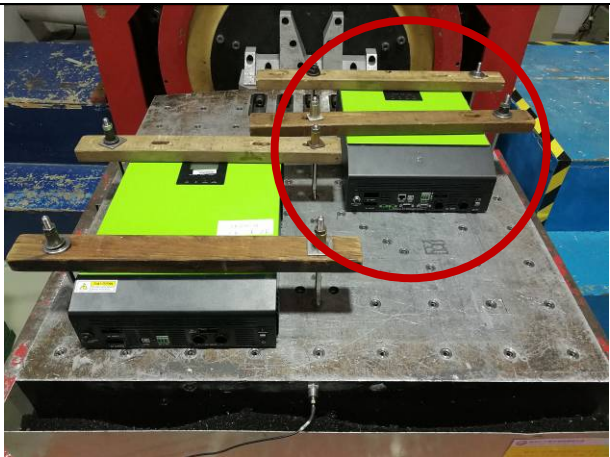
No.	Depiction	Photo
4	<p>Sinusoidal vibration test on X axis Mechanical shock test on $\pm X$ axis (Note: The red circle indicated the specimen)</p>

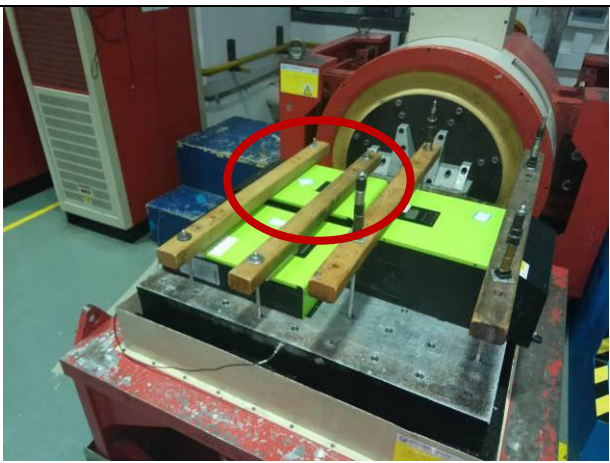
<p>A photograph showing a specimen mounted on a shaker table. The specimen is a small, dark rectangular object held between two wooden blocks. A red circle highlights the specimen. The shaker table is a large, flat metal surface with various fixtures and a control box.</p>
5	<p>Sinusoidal vibration test on Y axis Mechanical shock test on $\pm Y$ axis (Note: The red circle indicated the specimen)</p>

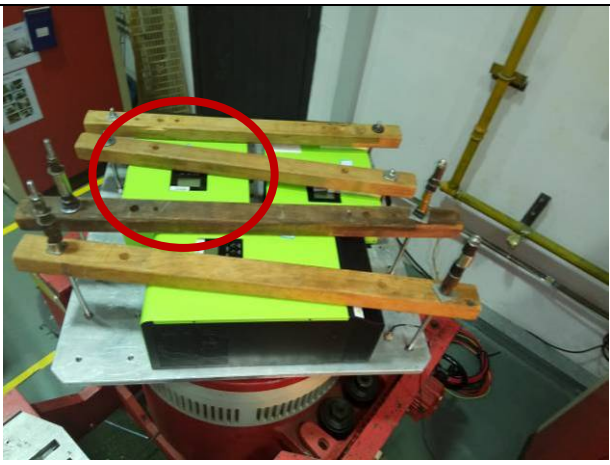
<p>A photograph showing a specimen mounted on a shaker table. The specimen is a small, dark rectangular object held between two wooden blocks. A red circle highlights the specimen. The shaker table is a large, flat metal surface with various fixtures and a control box.</p>
6	<p>Sinusoidal vibration test on Z axis Mechanical shock test on $\pm Z$ axis (Note: The red circle indicated the specimen)</p>

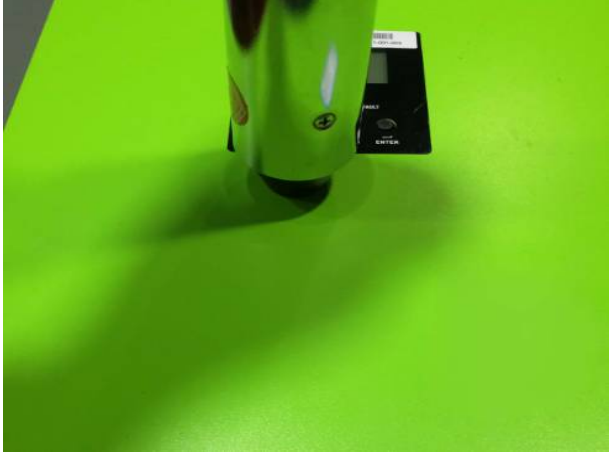
After the test, the specimen exhibited no external physical damage.

No.	Depiction	Photo
7	IK07 test

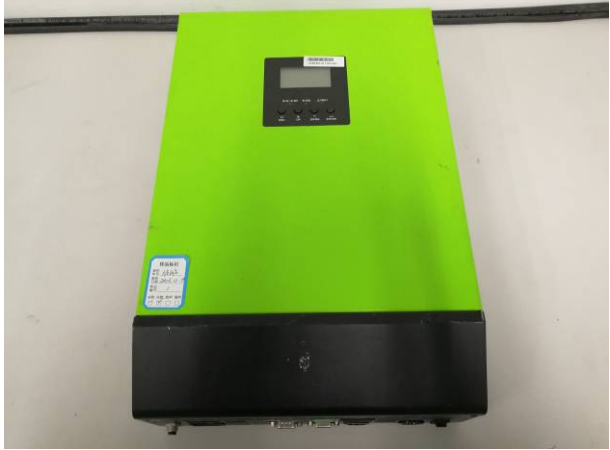
After the test, the specimen exhibited no external physical damage.

8	Inspection after test (Sinusoidal vibration test, Mechanical shock test and IK07 test)

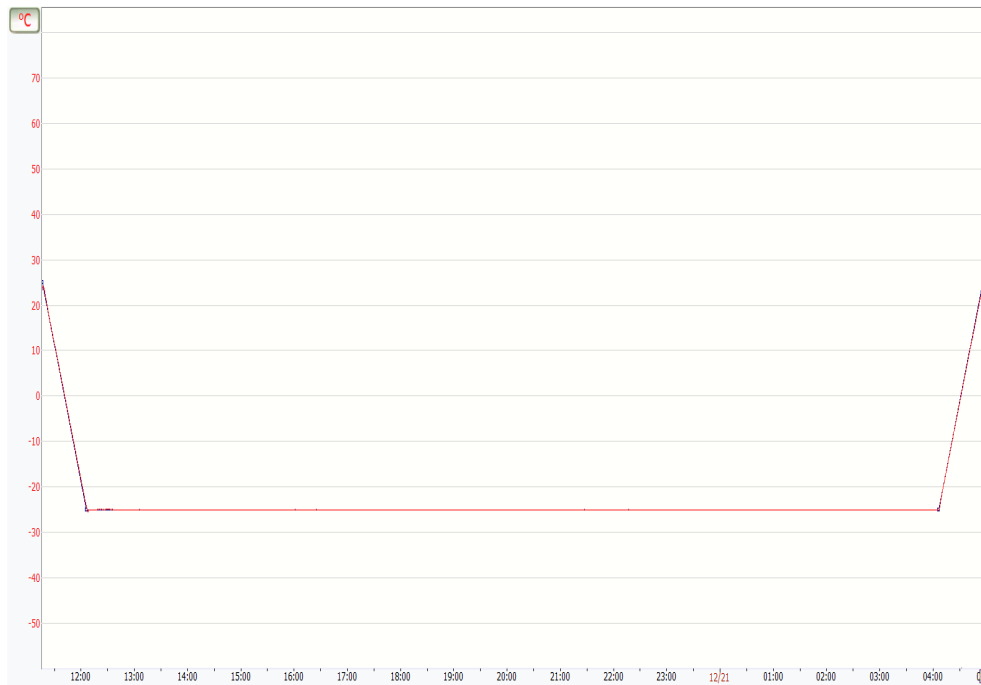
Temperature: $(-25 \pm 2)^\circ\text{C}$

Test duration: 16h

No.9 Low temperature test profile

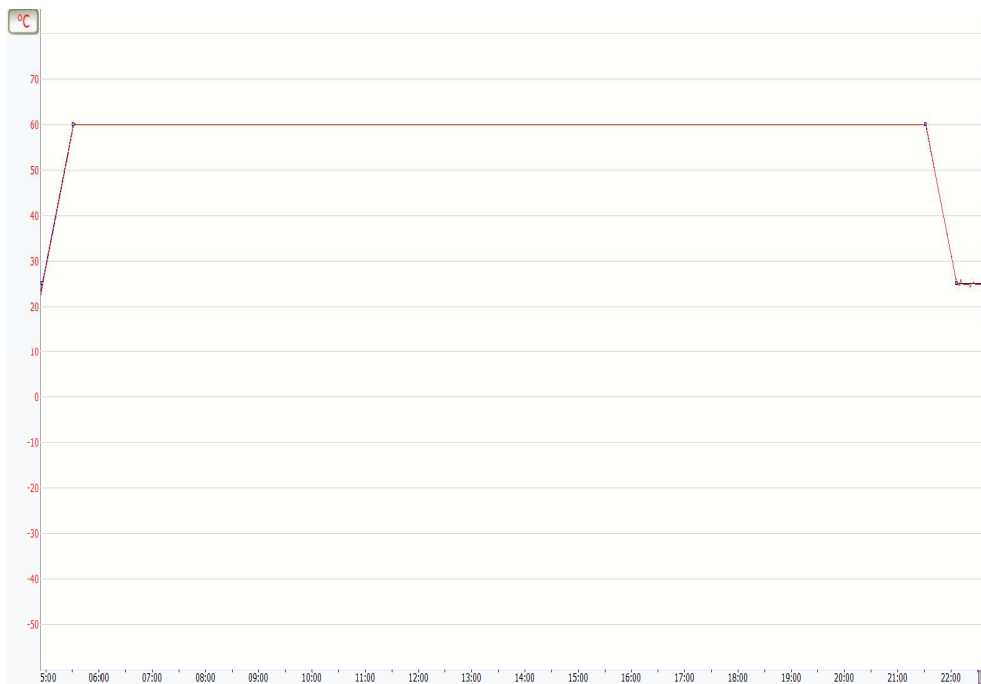
Temperature: $(60 \pm 2)^\circ\text{C}$

No.10 High temperature test profile

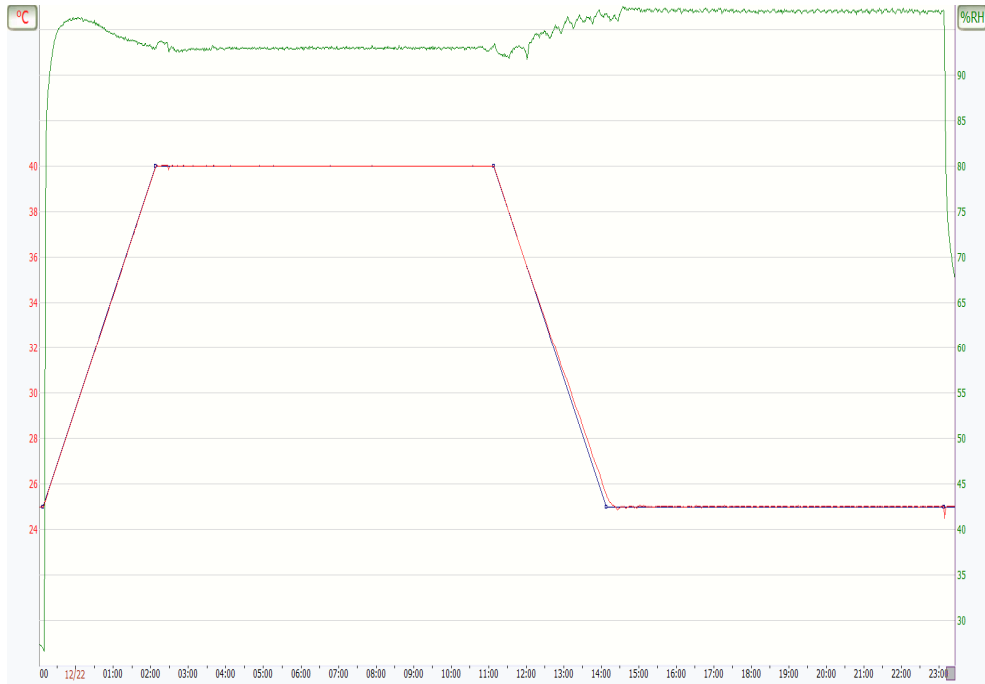
Step	Temperature(°C)	Humidity(%RH)	Test duration(h)
1. Ramp	25±2	97±2	1
2. Ramp	40±2	97±2	3
3. Dwell	40±2	93±2	9
4. Ramp	25±2	97±2	3
5. Dwell	25±2	97±2	9

No.11 Damp heat cyclic test profile

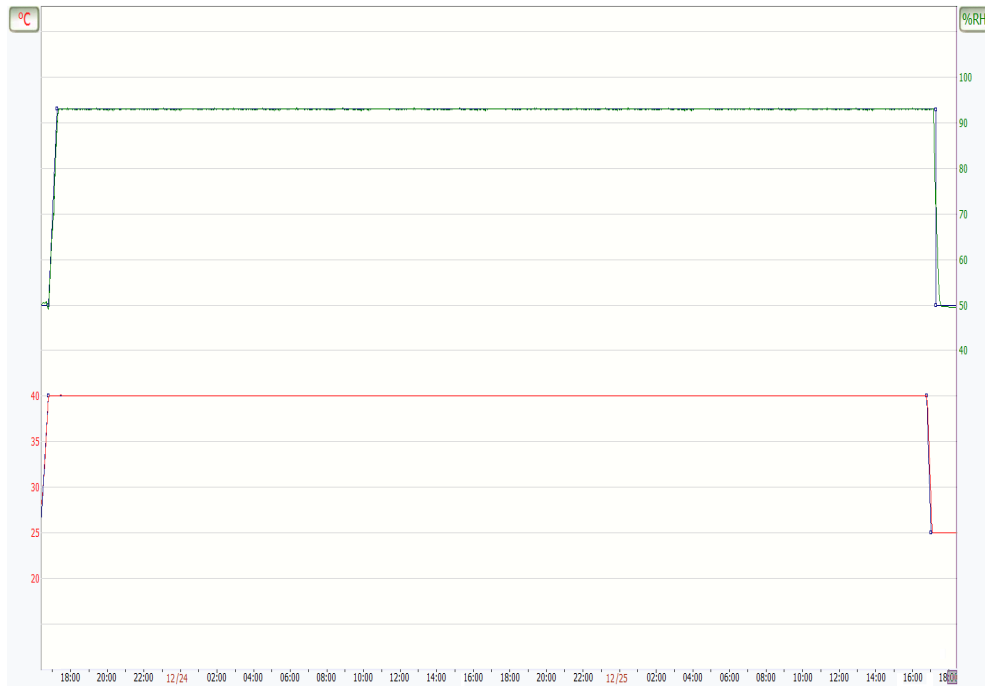
No.13 Damp heat test profile

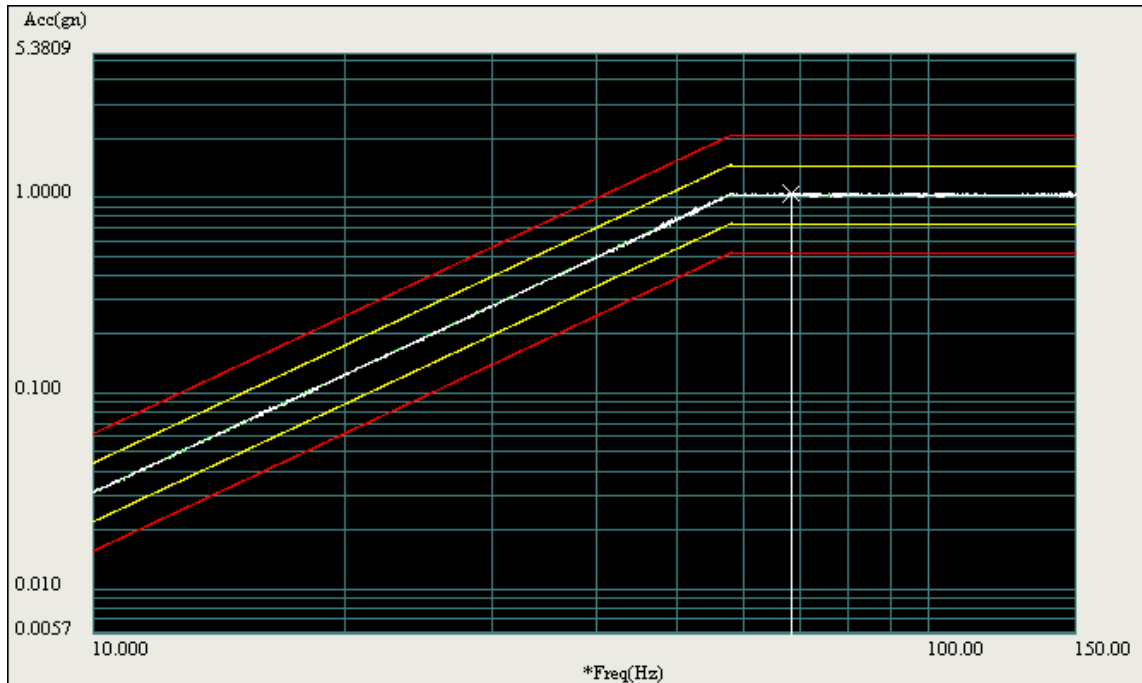
Control Peak: 1.0065gn
Frequency: 68.4201Hz

Full Level Time: 02:00:00
Time Remaining: 00:00:00

Sweep Type: Logarithmic
Sweep Rate: 1 Oct/Min

No. 14 Sinusoidal vibration test profile

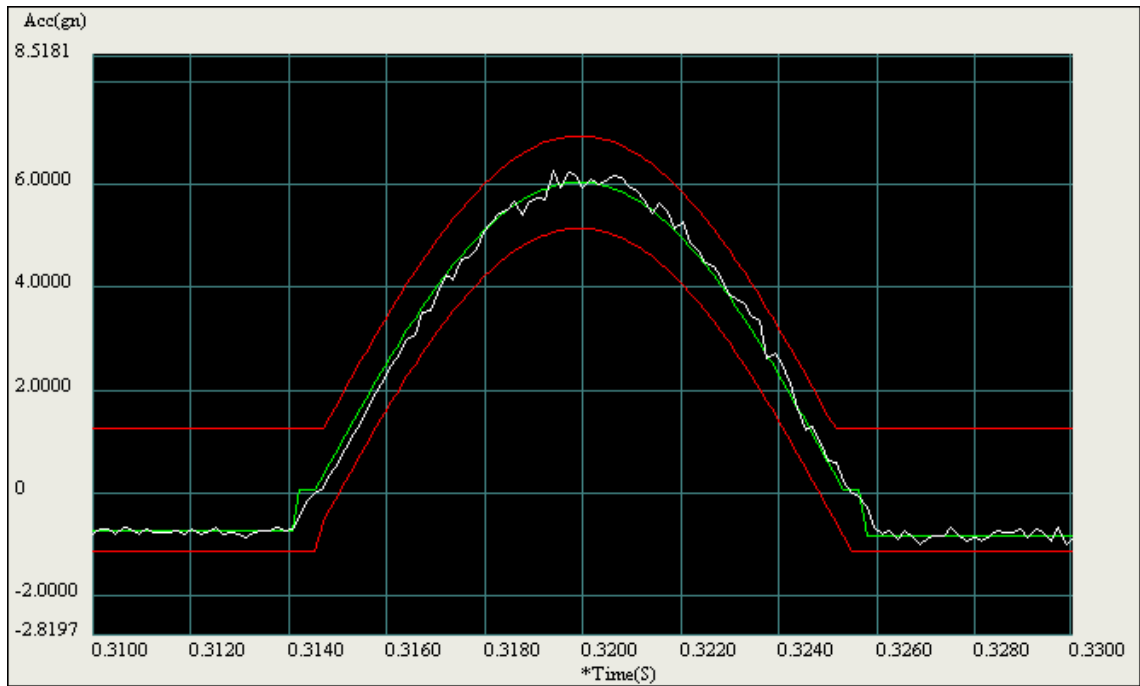
Control peak:	6.1377gn	Full Level Elapsed Pulses:	3
Pulse Type:	Half Sine	Pulse Width:	11

No.15 Mechanical shock test profile, positive axis

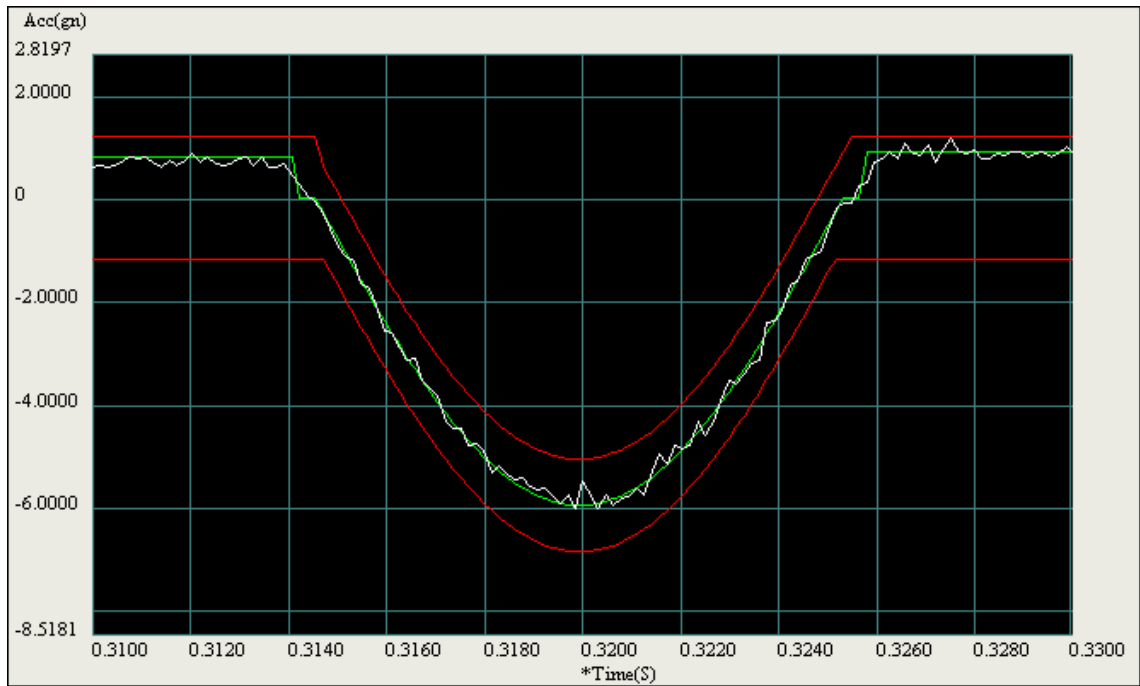
Control peak:	-6.0468gn	Full Level Elapsed Pulses:	3
Pulse Type:	Half Sine	Pulse Width:	11

No.16 Mechanical shock test profile, negative axis
